NASA CONTRACTOR  
REPORT

HYDROGEN ENVIRONMENT  
EMBRITTLMENT OF METALS

ROCKETDYNE

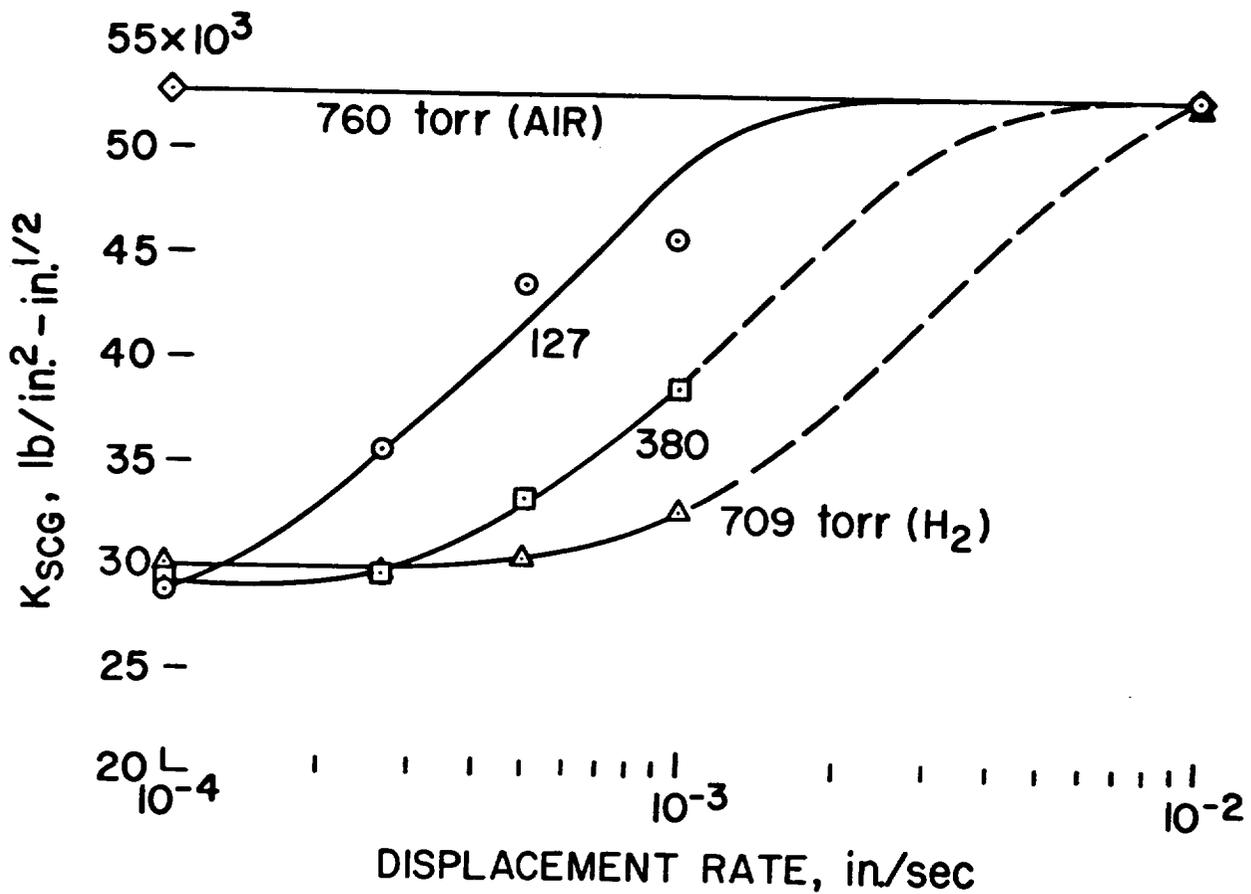
Figure 56 Effect of hydrogen pressure and displacement rate on the embrittlement of 4130 steel.

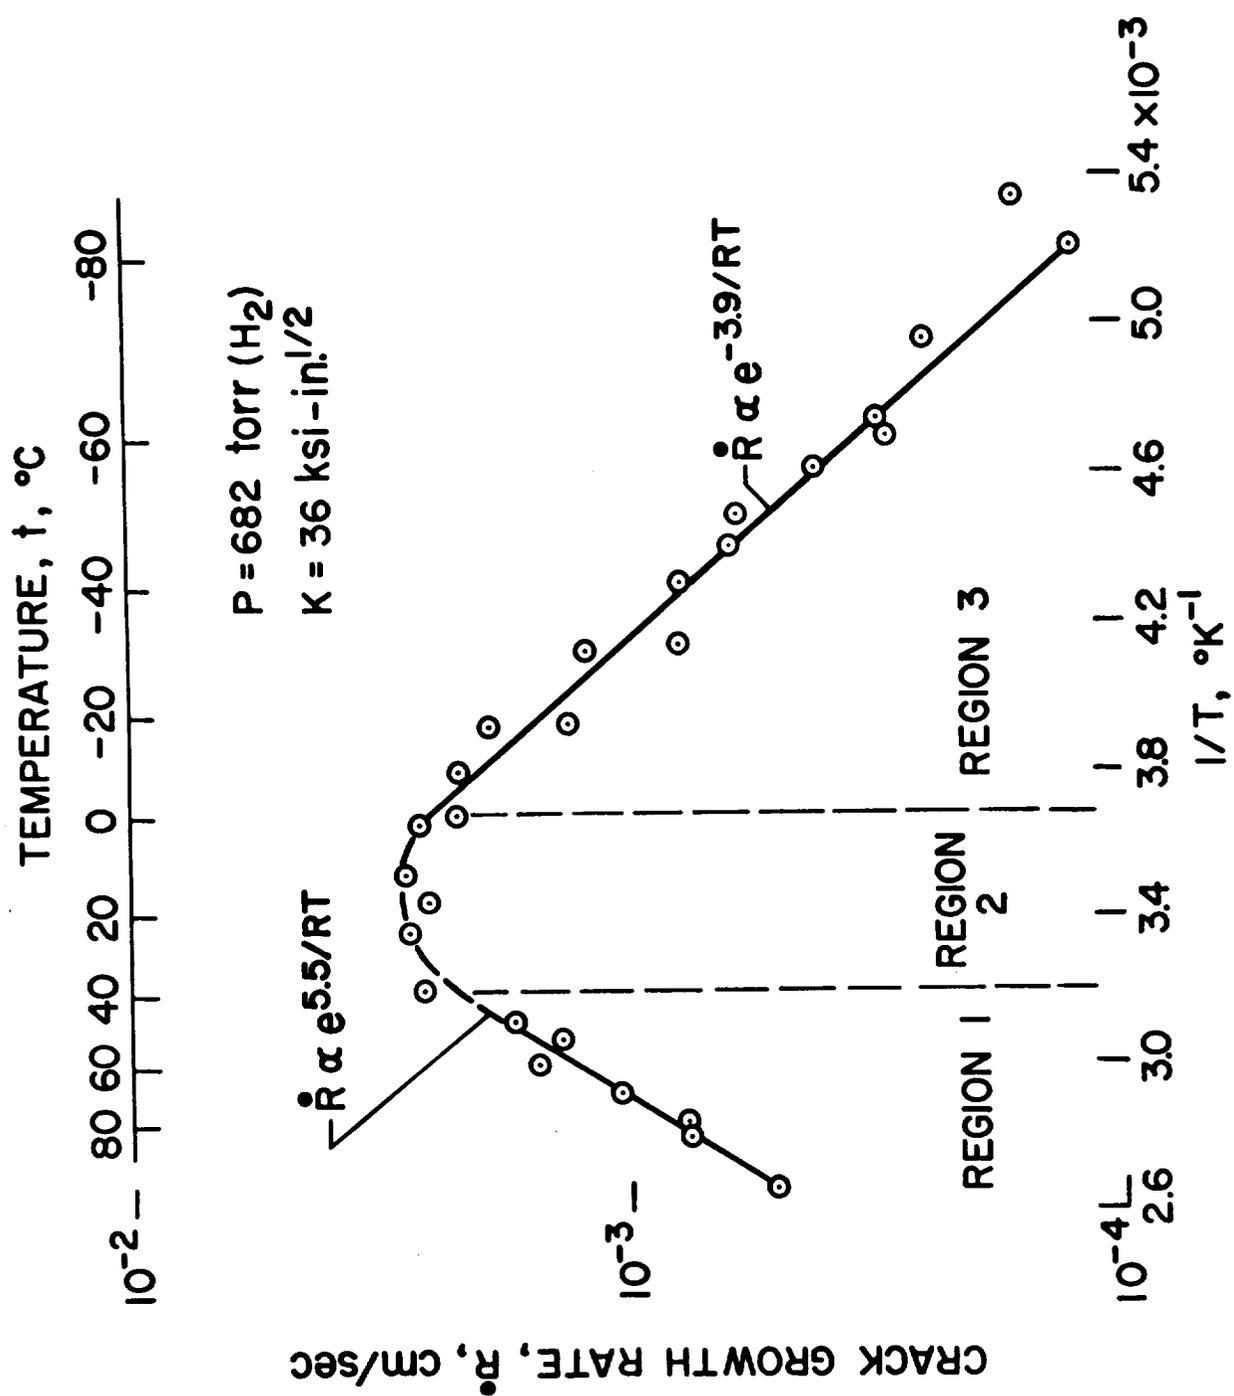
Figure 57. Temperature dependence of the slow crack-growth rate of 4130 steel.

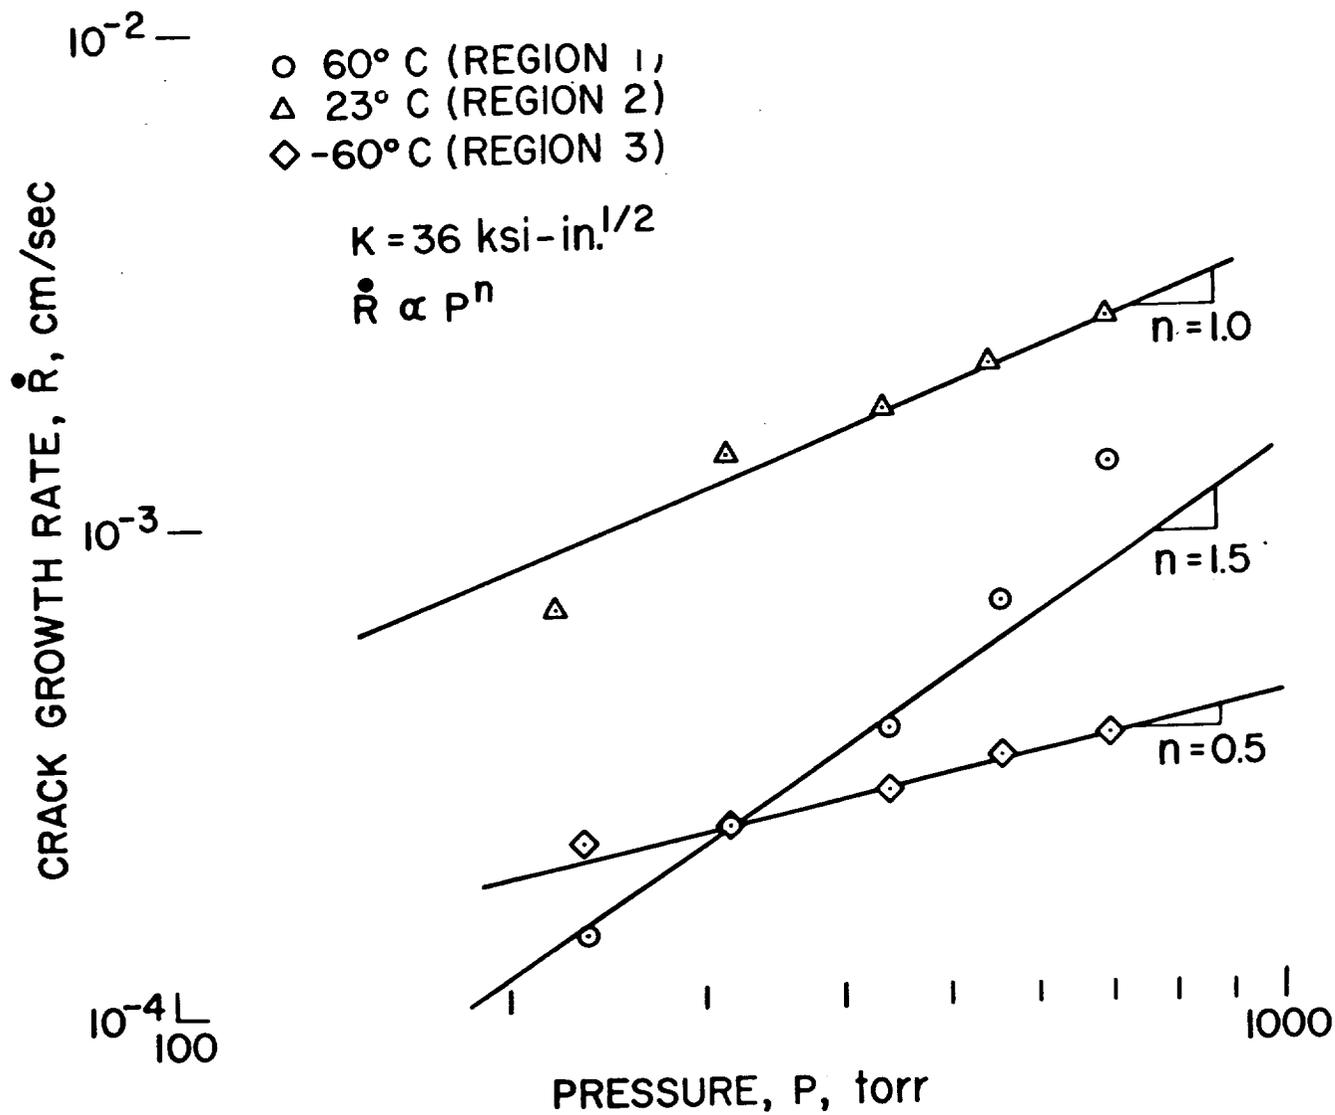
Figure 58. Effect of hydrogen pressure on the slow crack-growth rate of 4130 steel.

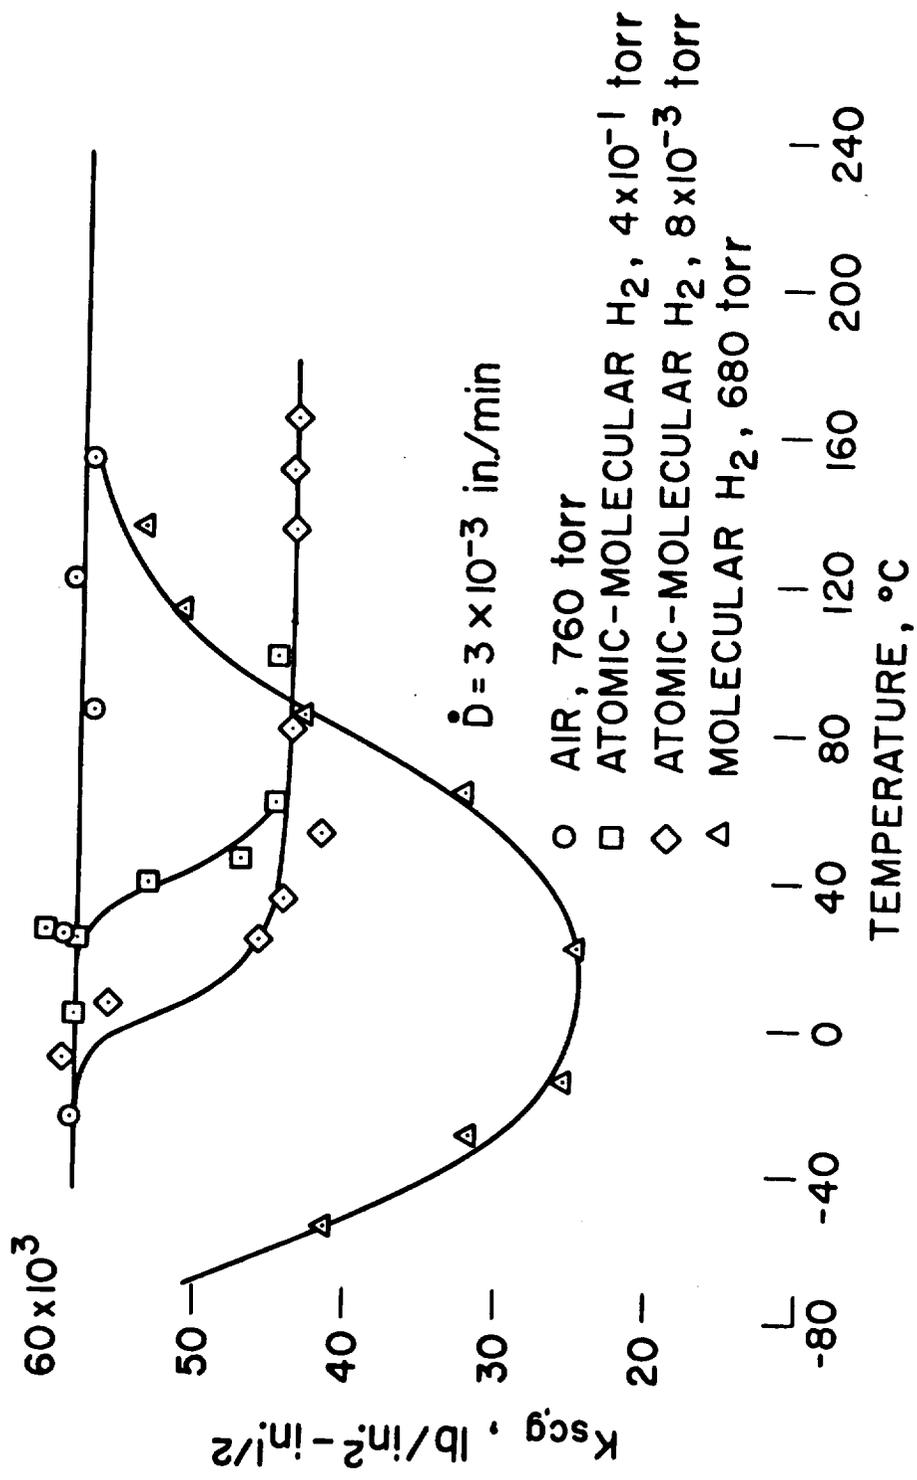
Figure 59. Effect of temperature on slow crack growth ( $K_{SCG}$ ) of 4130 steel in air, molecular hydrogen, and atomic-molecular hydrogen.

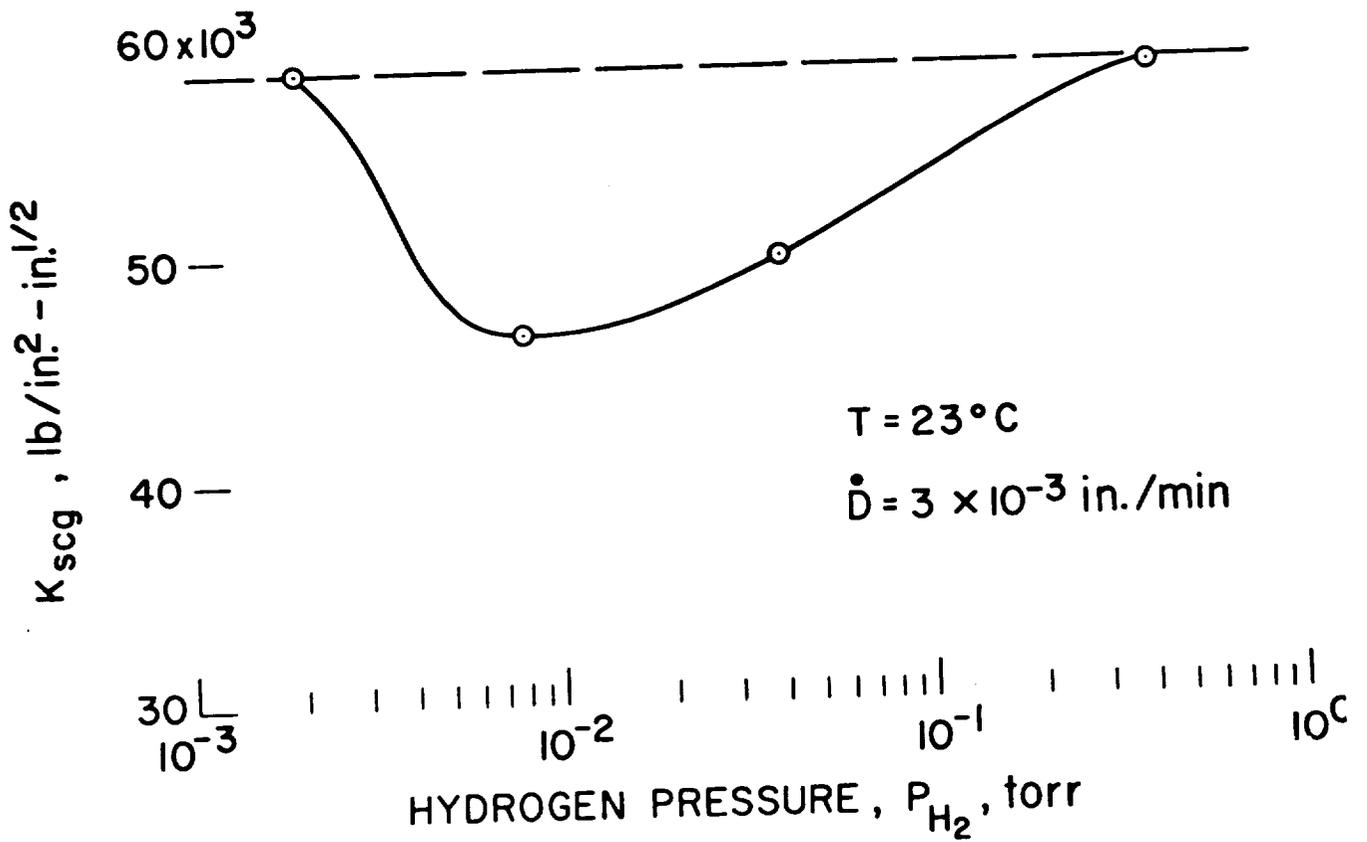
Figure 60. Dependence of embrittlement of 4130 steel on molecular hydrogen pressure in an atomic-molecular hydrogen environment.

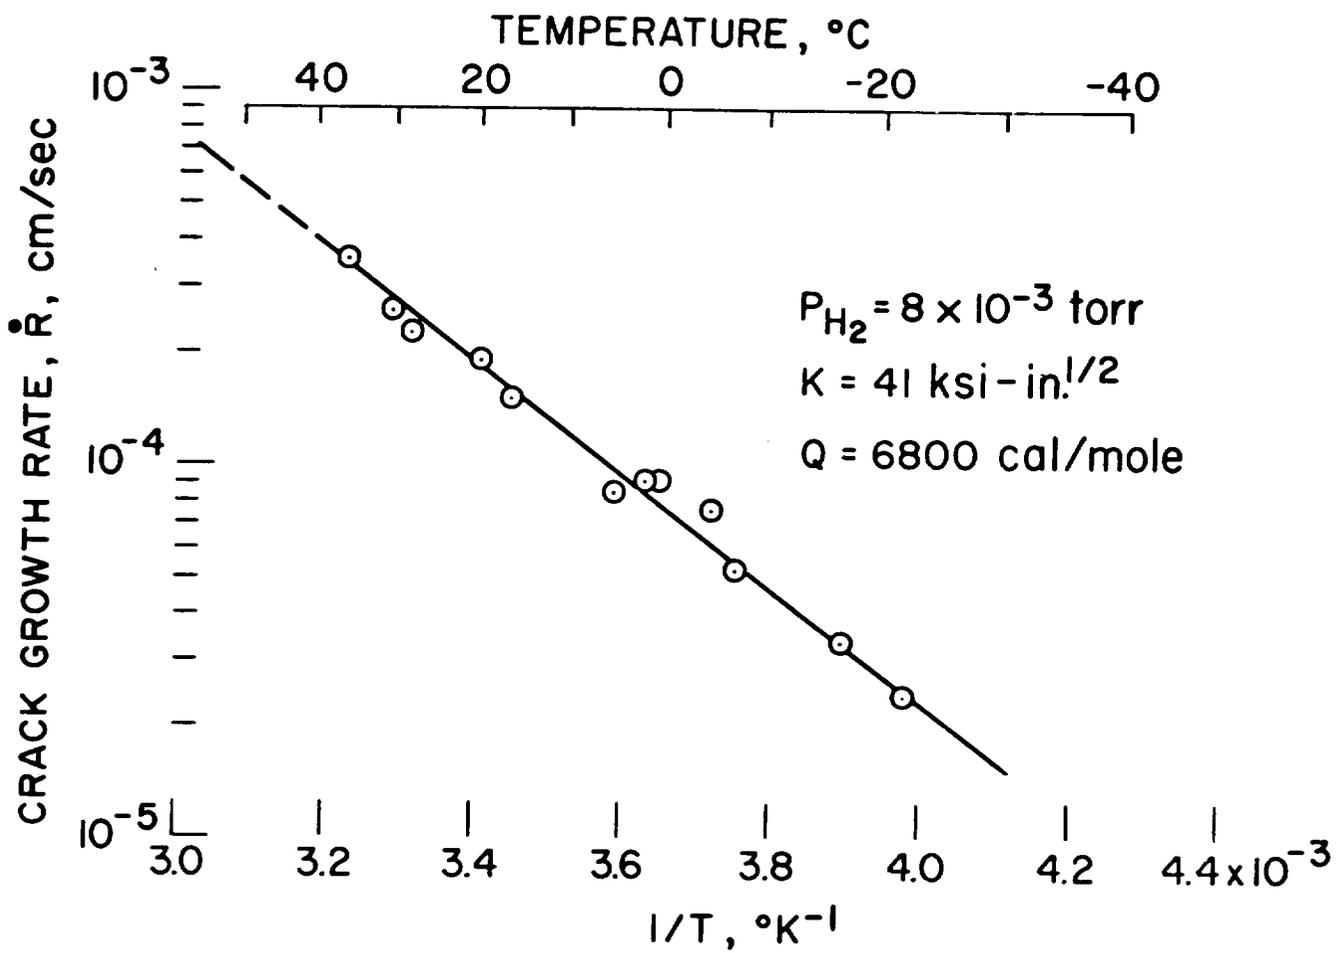
Figure 61. Dependence of slow crack-growth rate in 4130 steel on temperature in an atomic-molecular hydrogen environment.

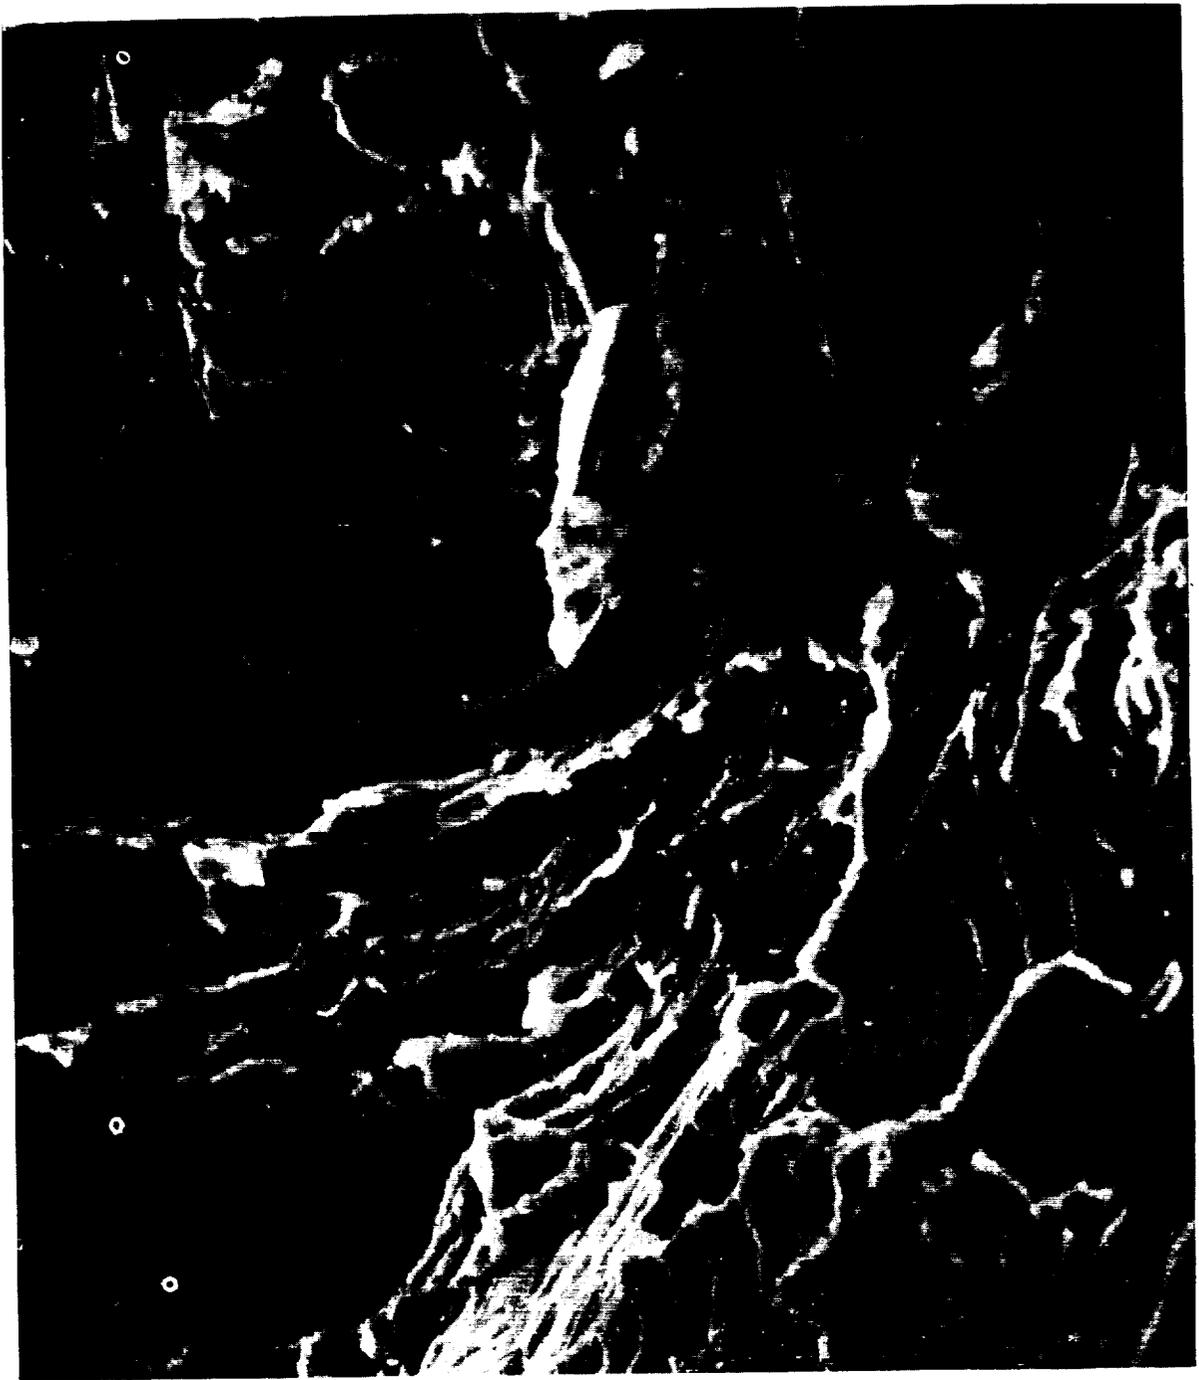
(C) SOLUTION-TREATED IN THE  $\beta$  FIELD AND STABILIZED TO OBTAIN COMPLETELY ACICULAR  $\alpha$  IN A  $\beta$  MATRIX

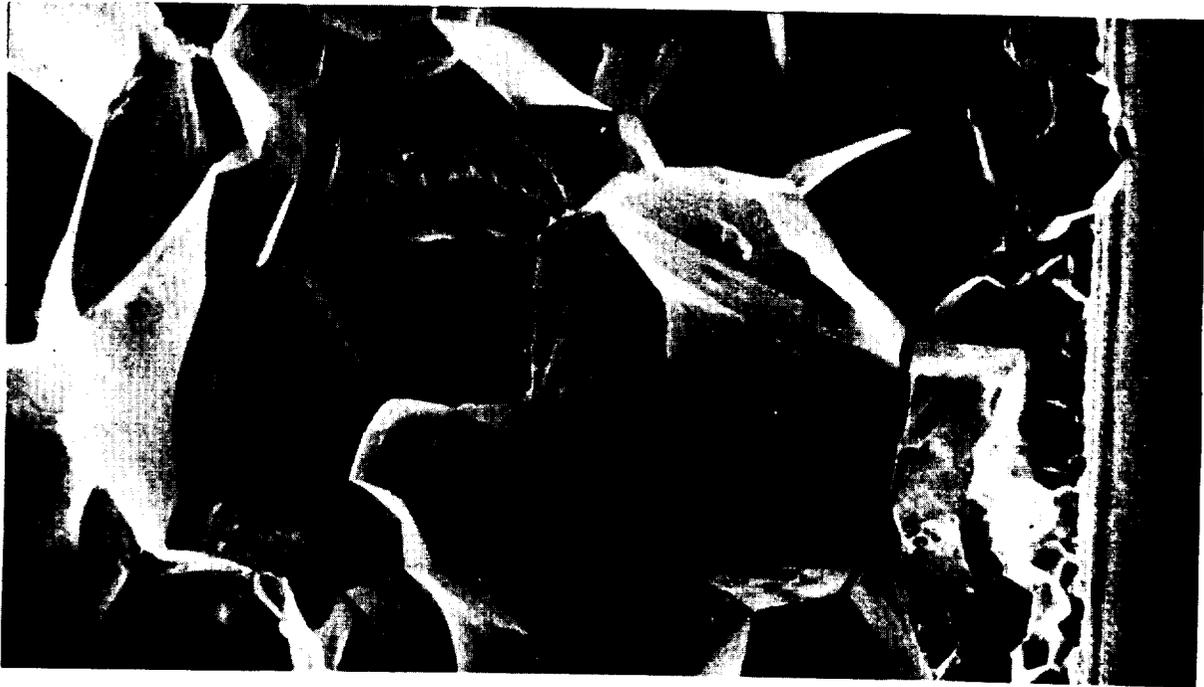
(A) Ni-4.5% Al TESTED IN 14.7 PSI PRESSURE HYDROGEN, REF. 31 (160X)

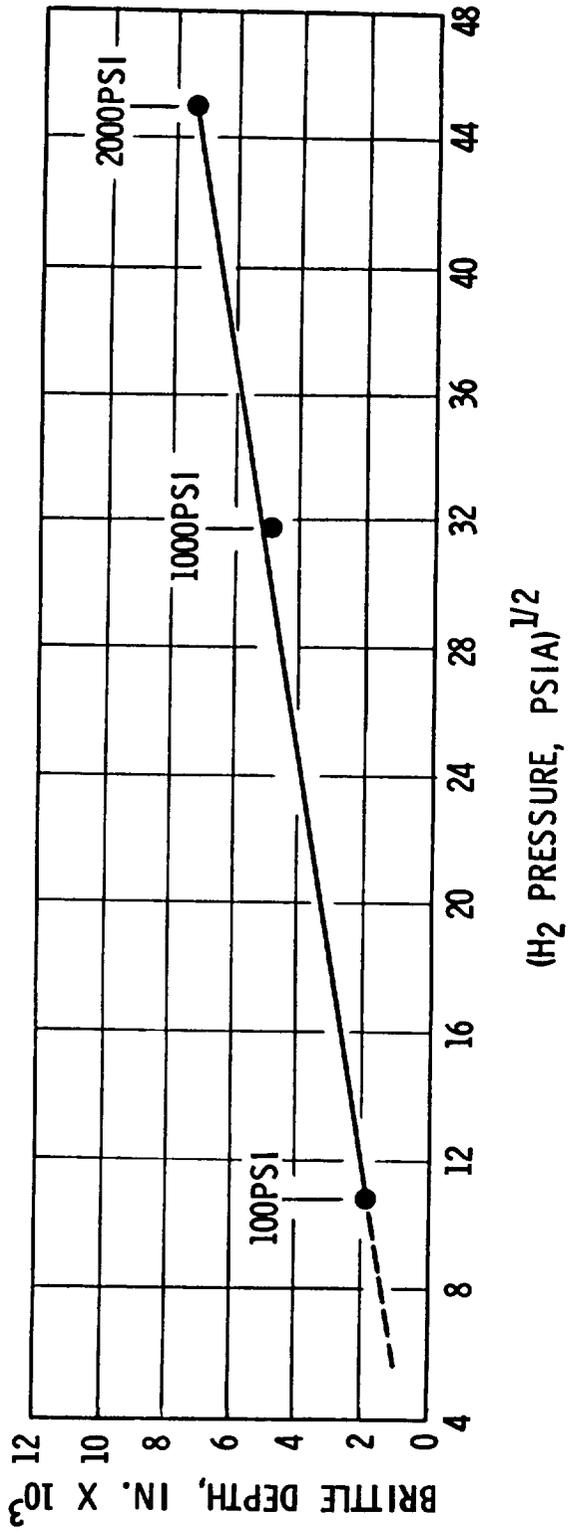
Figure 68. Brittle fracture depth of notched Inconel 718 specimens tested in high-pressure hydrogen.

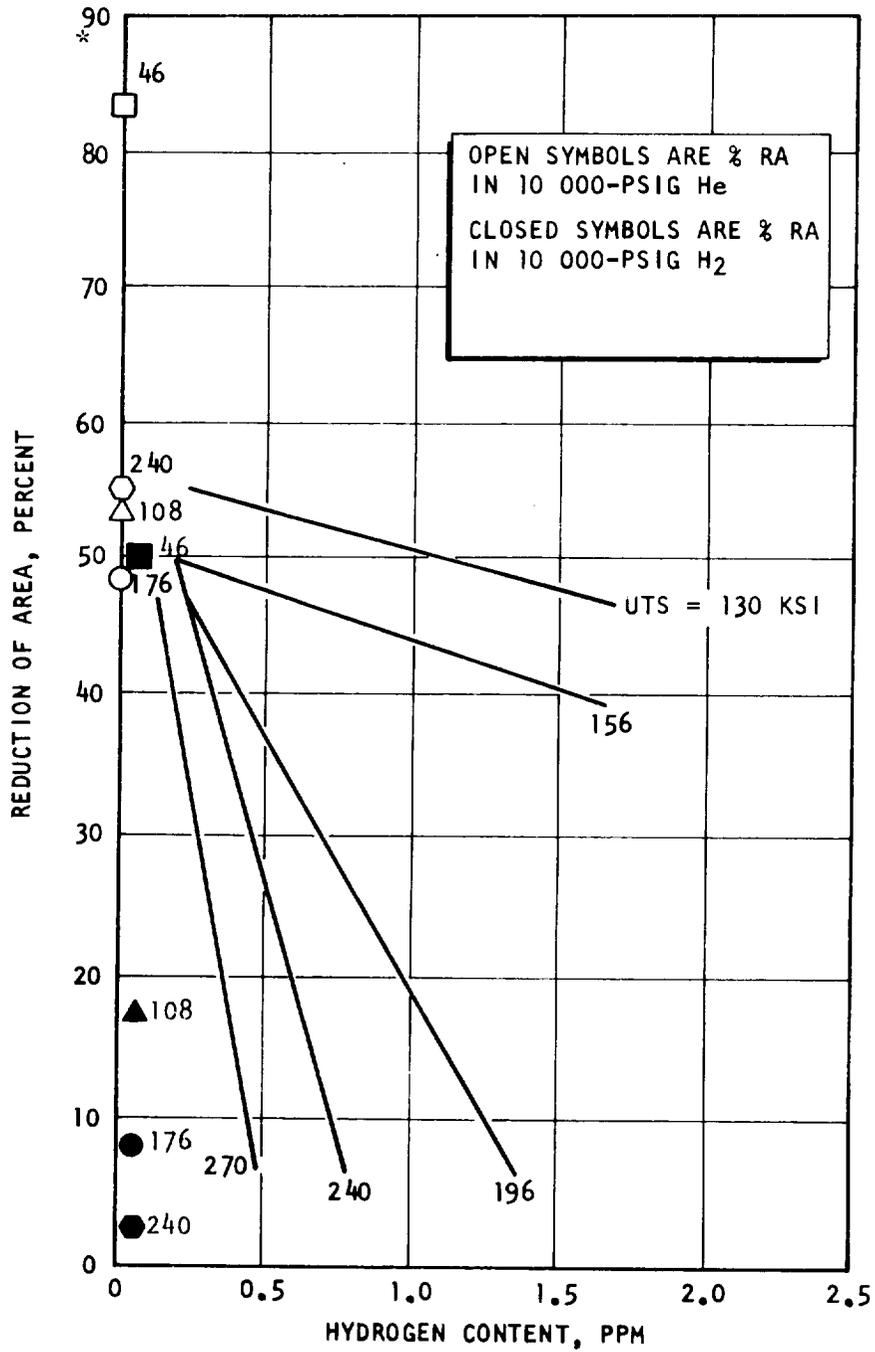
Figure 73. Effect of hydrogen content on the tensile ductility of high-strength steel (hydrogen content after exposure to 10000-psig hydrogen is approximately 0.1 ppm).

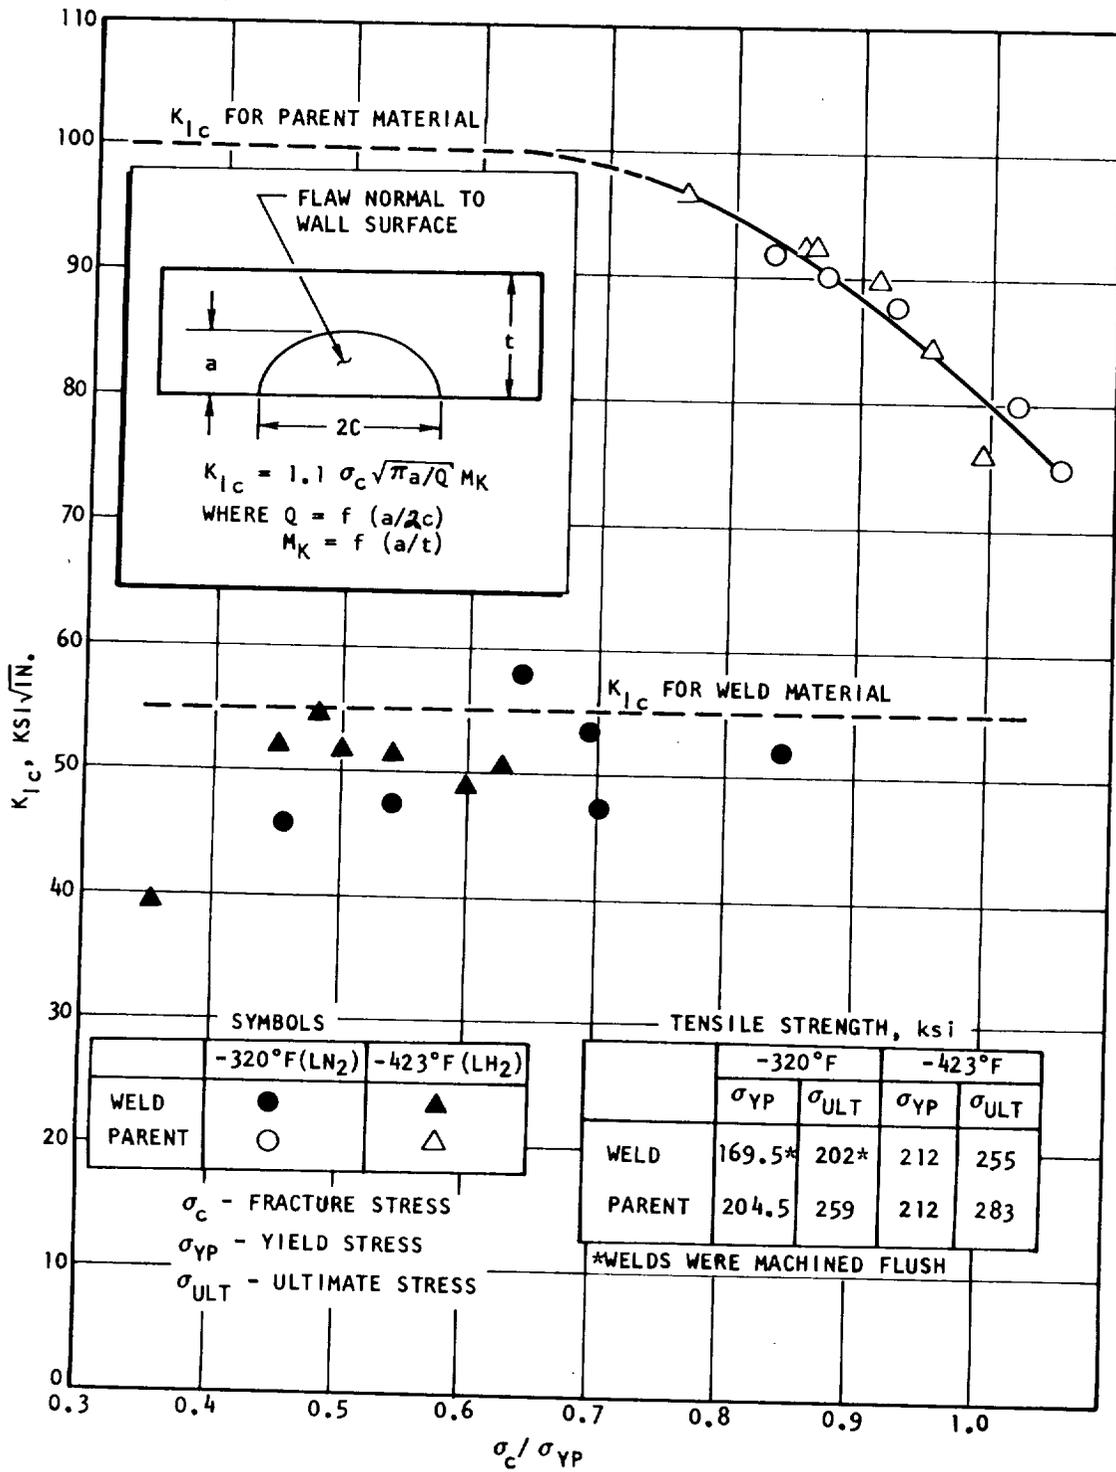
Figure 74. Fracture toughness and tensile strength of Inconel 718.

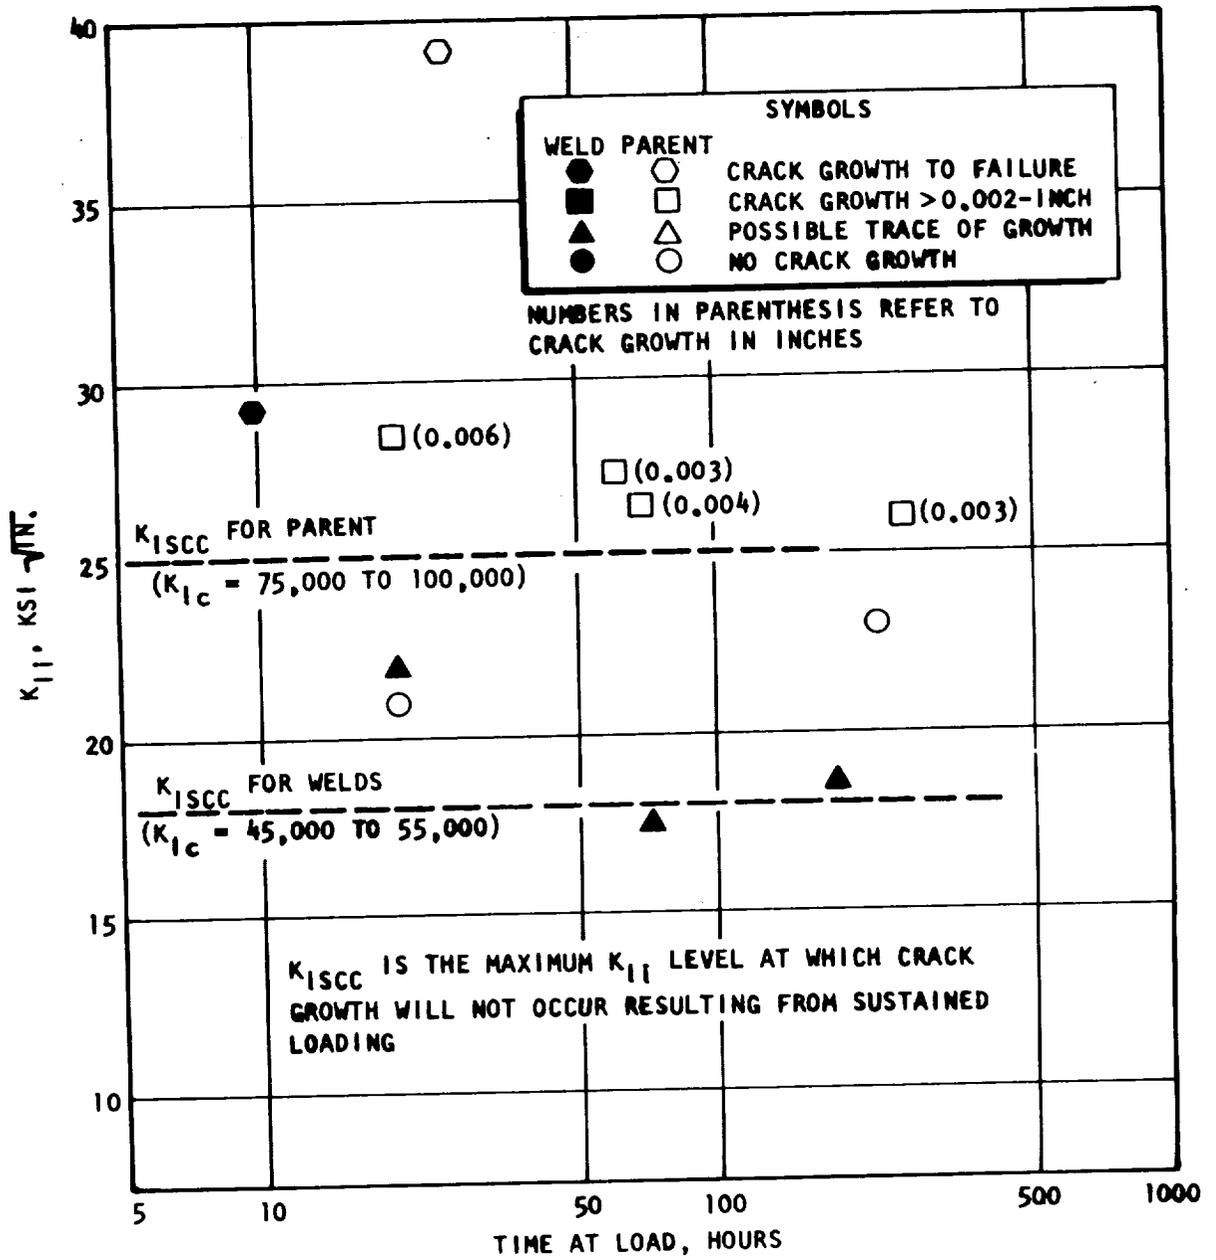
Figure 75. Crack-growth behavior of surface-flawed Inconel 718 specimen tested under sustained load in gaseous hydrogen at  $-100^{\circ}$  F.

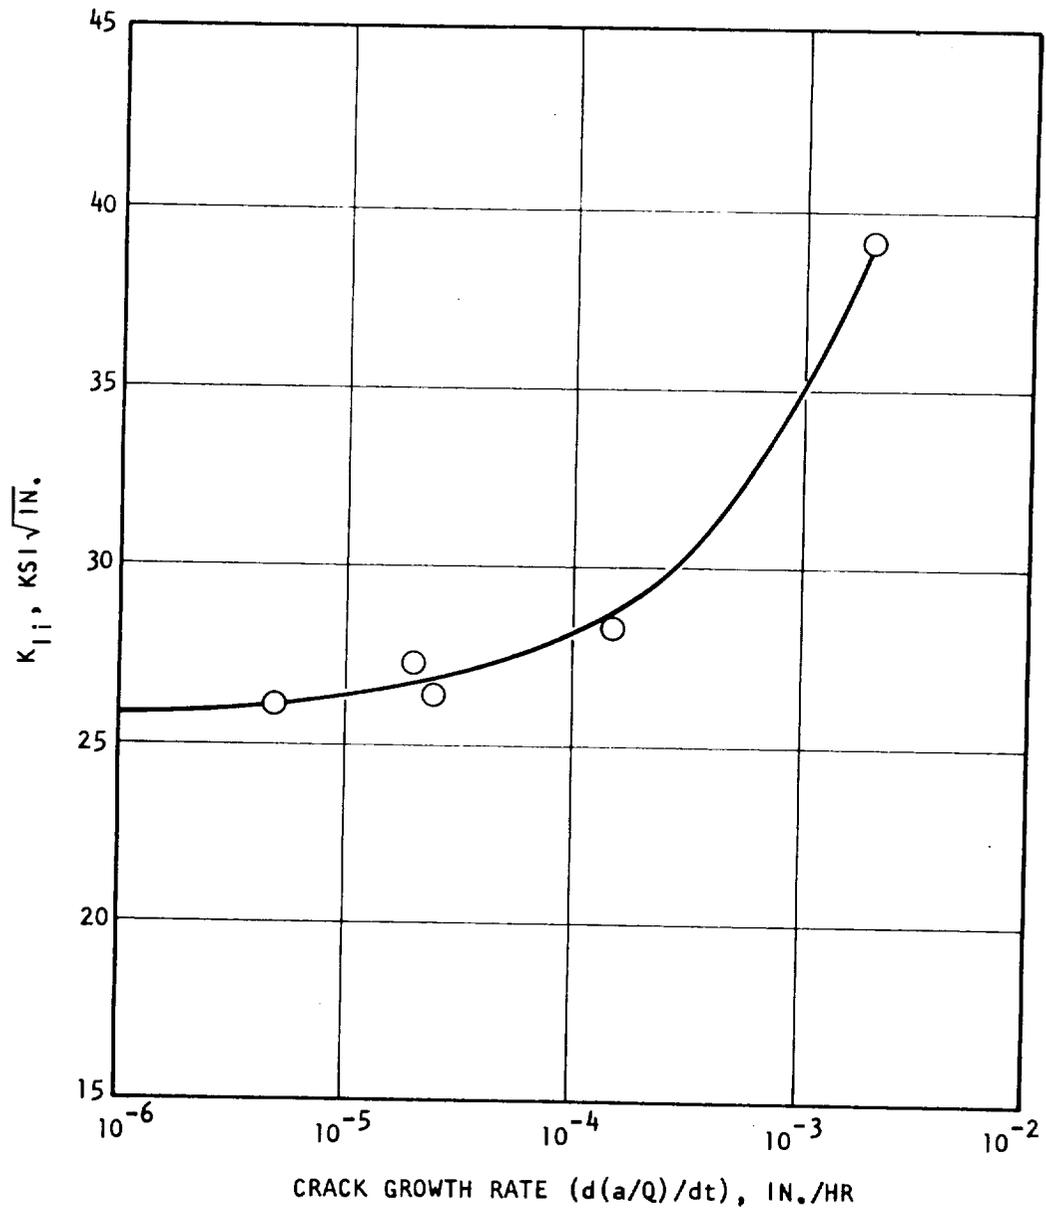
Figure 76. Crack-growth rate of Inconel 718 parent metal under sustained load in gaseous hydrogen at  $-100^{\circ}$  F.
